**DESERT VARNISH (PERMEON<sup>TM</sup>) EVALUATION  
DABNEY STATE PARK (Region 1)**

**Construction Report**

**Experimental Features Project 94-02A**

April 2000

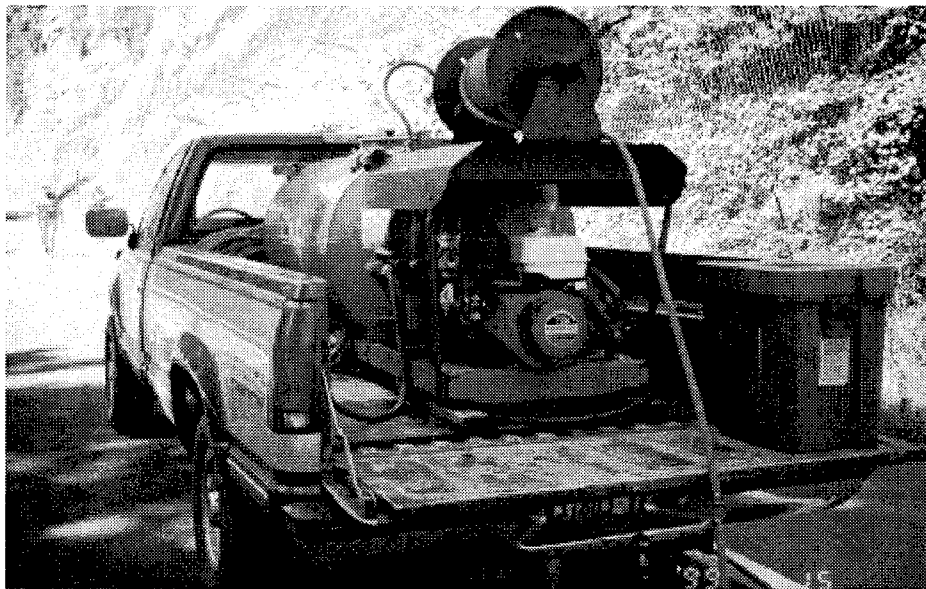
The next morning, the desert varnish application went smoothly, with about 76.25 m (250 ft) completed by 10:00 a.m. The PERMEON™ (desert varnish) had been mixed with water in a 5:1 solution, 76 L (20 gal) of PERMEON™ to 100 gallons of water. The mix was carried in the back of a pickup truck in a 950 L (250gal) tank. A compressor was used to pressurize the spray to about 1380 kPa (200 psi). The sub-contractor, Livingston, Inc., used a 200-foot hose and an agricultural-type hand-held nozzle to spray the shotcrete-coated cliff. The equipment is shown in Figure 3.1.

Figure 3.1: Spraying Equipment to Apply Desert Varnish

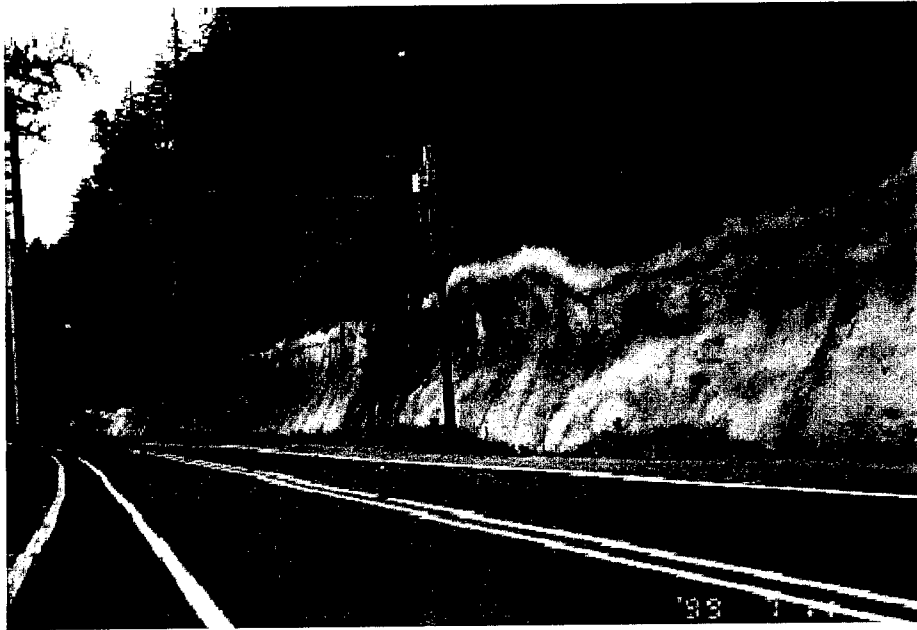
Two possible problems were noted: water running over the cliff in a few areas from a local land owners' irrigation effort on the hill above the site (see Figure 3.2), and mineral stains from an unknown source appearing on some of the rocks just above the shotcrete. These two areas should be closely monitored.

Figure 3.2: Dark Streaks on Shotcrete caused by Irrigation Water from Above

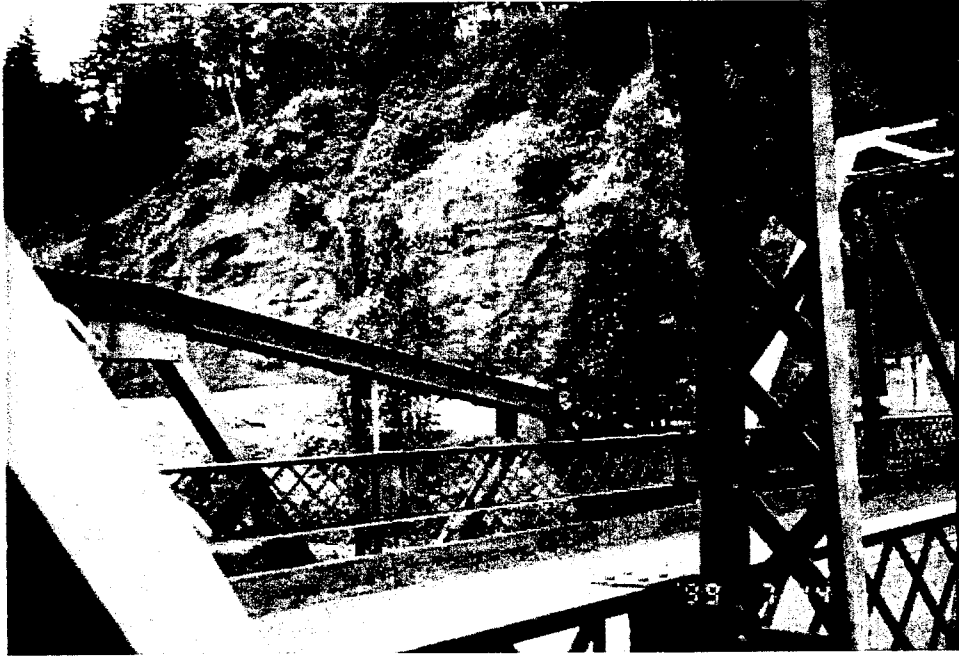
After two weeks, half of the shotcrete with the desert varnish was starting to blend well with the surrounding cliff. The section west of the bridge is well matched, as can be seen by comparing Figures 4.1 and 4.2, which show the condition before and two weeks after construction. East of the bridge, the section is still lighter than the cliff, as shown in Figures 4.3 and 4.4, which also show the before and two weeks after construction condition. This section will be watched closely as it should darken with age.

Figure 4.1: Shotcrete West of Sandy River Bridge before Application of Desert Varnish

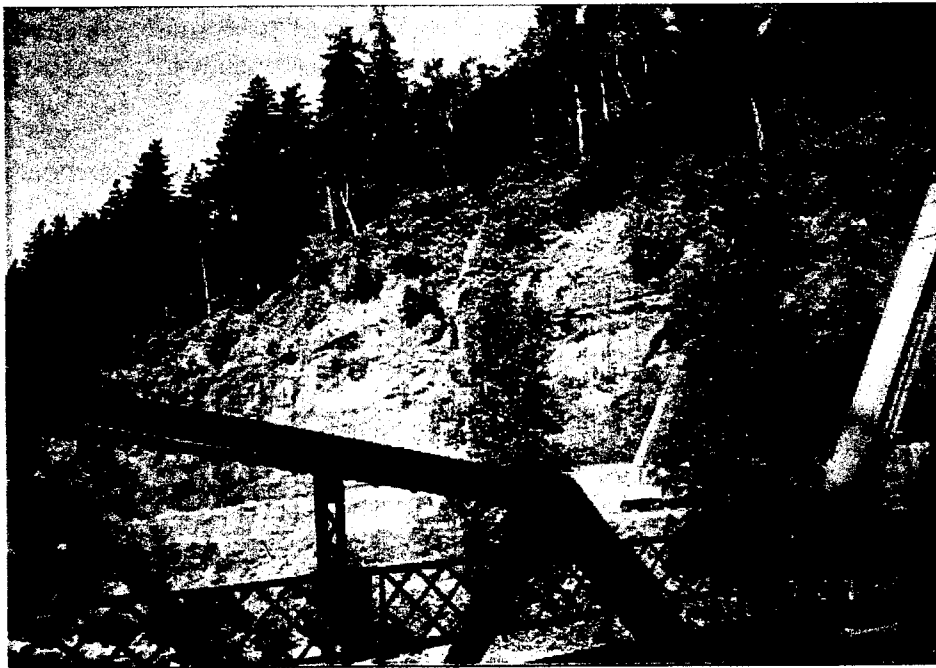
Figure 4.2: Shotcrete West of Sandy River Bridge after Application of Desert Varnish

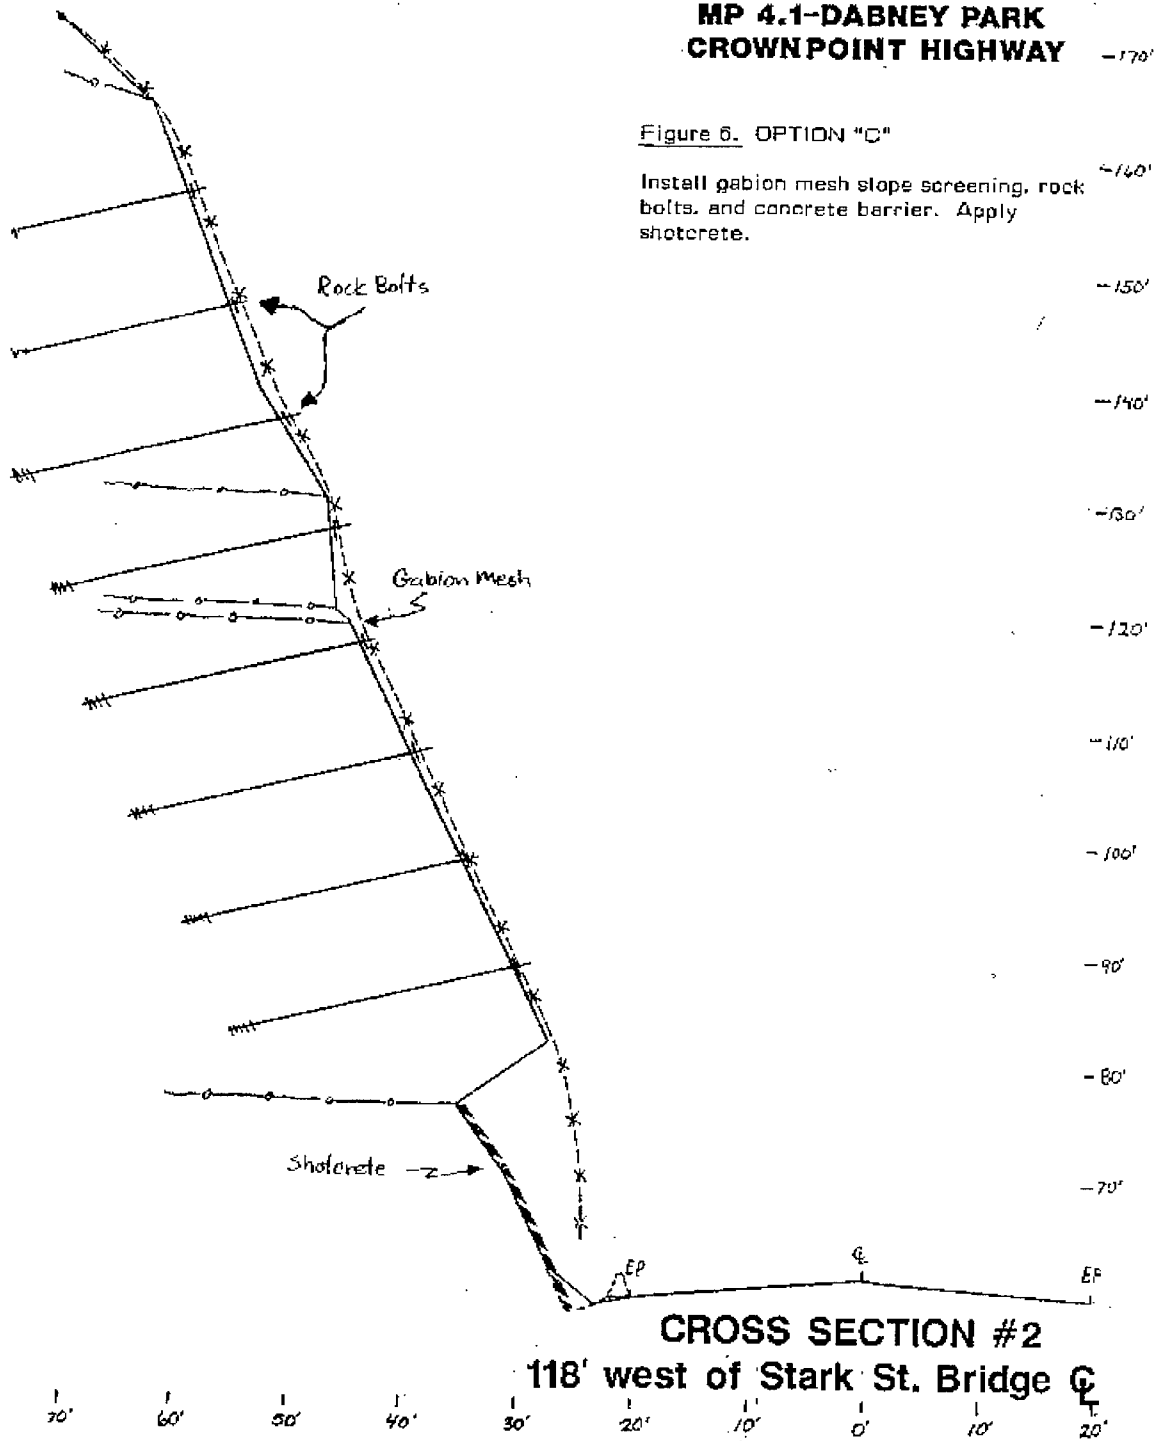
Figure 6. OPTION "C"

### MP 4.1-DABNEY PARK CROWNPPOINT HIGHWAY

Install gabion mesh slope screening, rock bolts, and concrete barrier. Apply shotcrete.

A cross section of the cliff is included in Appendix A. Located in the north Willamette Valley, the annual rainfall is about 1143 mm (45 in). The winters are mild with only a few freeze-thaw cycles. The mean January temperature is 4 °C (39 °F), while the mean July temperature is 21 °C (69 °F).
